The Building Stones Walk starts and ends at the Buckinghamshire County Museum, Church Street, Aylesbury. Route is composed of 32 identified stops with a brief description and photo shown below. The route will examine the local Aylesbury stones, stones sourced from further afield in Buckinghamshire, other parts of the UK and abroad. The route will also look at the topography created by the resistant Portland limestone and the easily weathered underlying Kimmeridge Clay. The route is calculated to be under 1 mile (1.6km), mostly paved although streets with setts can be very uneven with potential tripping hazards. Allow 1 to 2 hours depending on number of stops.

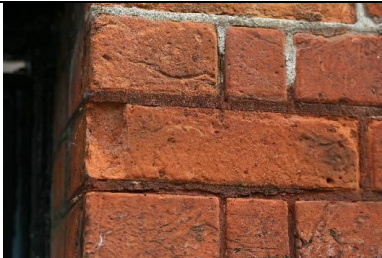
A	Church Street, Museum.	Kimmeridge Clay bricks (Red and Silty from uppermost unit: Hartwell Silt, dug for brick making in Hartwell and Cambridge Street). Note how some bricks have been over baked/burnt and are a darker colour, the stripes of red are where they were stacked next to other bricks in the kiln.

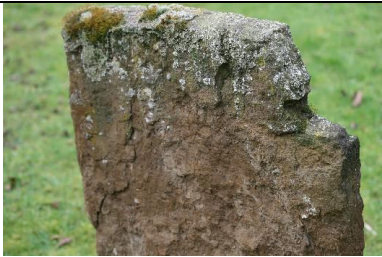
B	St. Mary's Church, Graveyard. Aylesbury.	Oldest gravestones are made from local sandy brown "Marlstone", with belemnites, from Oxon-Northants.  The arrival of the Aylesbury branch canal in 1815 encouraged these to be replaced by Yorkstone from N England.

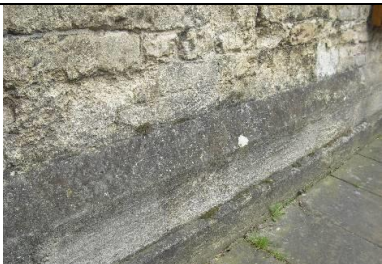
C	St. Mary's Church, South and East side. Aylesbury.	Church fabric. Badly weathered local Portland Limestone fill, Corners of Jurassic Limestone. Base possibly Headington Hard? East facing window of brown-weathering Taynton Limestone from Oxfordshire.

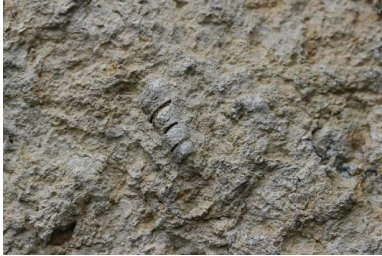
D	St. Mary's Church, North side. Aylesbury.	Also examples of "Roach" from Portland Lst, with Trigonina and Portland Screw (Aptyxiella portlandica) fossils. Rare blocks of Arkose sandstone and Dark brown Lower Greensand.

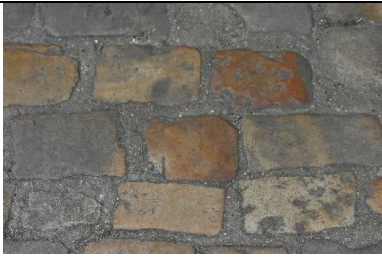
E	St. Mary's Square, Aylesbury.	"Sarsen stone" also known as Denner Stone can be found in small clusters throughout the Chilterns. These rocks are referred to as silcretes, they have a silica (quartz) cement and are very hard and resistant to erosion. Flying buttress of sarsen stones retaining wall of bricks (original replaced).

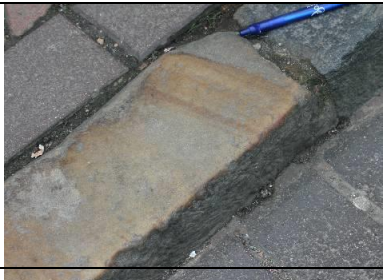
F	St. Mary's Square, Aylesbury	Sarsen curb stones. A large number were historically quarried and brought to Aylesbury as curb stones and setts.

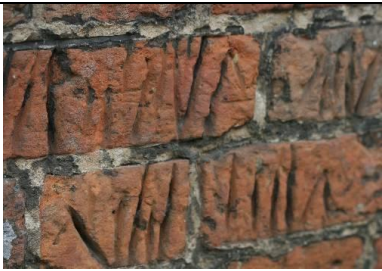
G	Pebble Lane,	Red Kimmeridge Clay (Hartwell Silt) Bricks in old School & Museum building. NB low height of grooves made by school children sharpening their writing tips for slate boards. Slate pencils were made of slate or 'soapstone'.

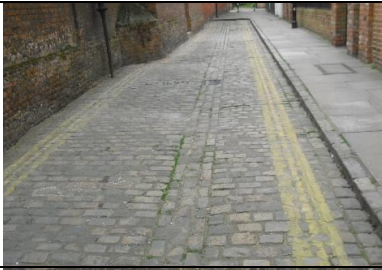
H	Pebble Lane,	Note Medieval-style central gutter in sarsen stone setts. Still in use today as seen from drain grating. Also of interest is the surviving church pump in Pebble Lane which dates to 1840, this is the only surviving example of the public pumps which supplied drinking water to the historic core of Aylesbury.

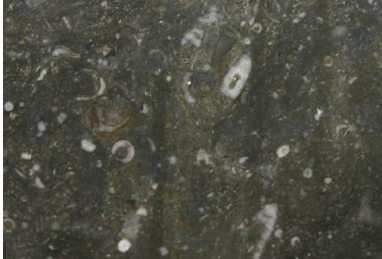
I	Kingsbury Square water clock	Black Carboniferous Limestone with crinoids and corals, probably from Kilkenny, Eire. The 'time piece' design concept and the design for the square itself was created by Design services of Aylesbury Vale District Council in 2004 with a grant from the Office of the Deputy Prime Minister.

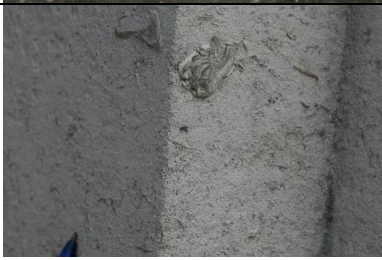
J	Market Square-John Hampden statue	Portland Limestone from Dorset, distinctive light grey limestone with fossil fragments. Base of the statue structure is made from a Dalbeattie granite. The statue was erected in June 1912 to honour John Hampden's (c.1595 – 1643) fight against tyranny and unjust 'laws'. "For England, Parliament and the people!"

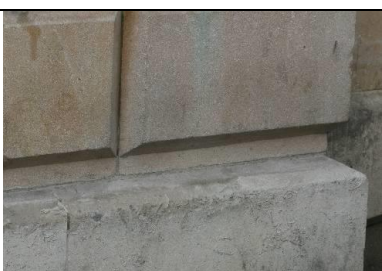
K	Market Square-Lloyds Bank	Portland Limestone from Dorset, base. Bath (?) stone upper elevation with coarse limestone and in places concrete repair! Note also ornamental honey comb finish on some of the facing stones this is known as 'Vermiculation'. This provides an architectural contrast to the plain 'Ashlar' finished blocks

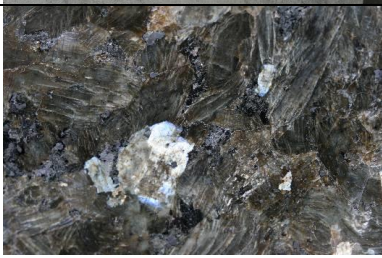
K	Market Square - Niche & Bon Marche	Black Larvikite (Norway). In 1936 Burtons the Tailors decided this rock should front all of its shops as a national corporate Identity.  Note: compare this with the modern Larvikite variety being used to face Minute Baguettes (stop M).

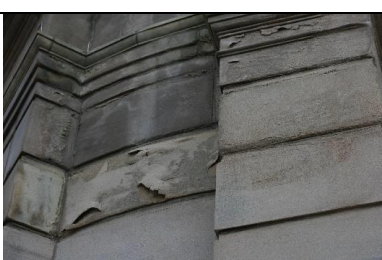
L	Market Square-Disraeli statue & HSBC Bank	Pennant Sandstone base (Wales). HSBC Bank – Similar sandstone with sedimentary features and diagenetic staining. Stone has started flaking badly about 2-3m above the group. Possibly the result of water not being directed away from the face adequately and gypsum build up and expansion.

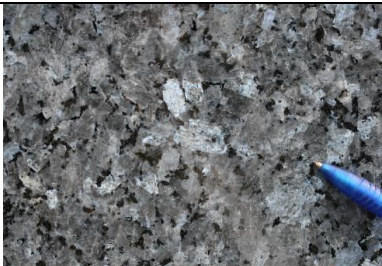
M	Market Square- Minute Baguettes	Larvikite ( Norway) much lighter than the 1936 variety used at Burtons. Rock extracted from the pluton is paler as excavation goes deeper. (Conversely, shallow-dug Victorian Larvikite is black).

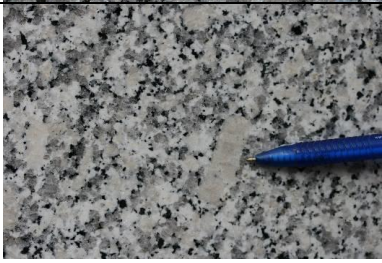
N > O	Market Square- Britannia	Front facing – Granite or ?Granodiorite (more Plagioclase feldspar) Very pale in colour. Entrance– SW English Granite, a series of Permian age intrusion e.g. Dartmoor, Bodmin Moor etc.

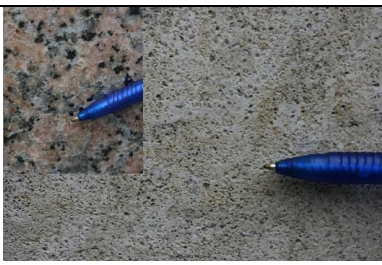
N > O	Market Square-Hale Leys Entrance	Pillars, Coarse Jurassic limestone with Pink granite bases.

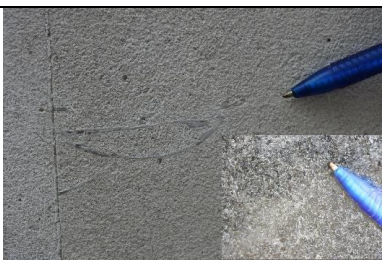
N > O	Market Square- NatWest Bank	Dolerite base, upper elevation– Portland Limestone from Dorset.

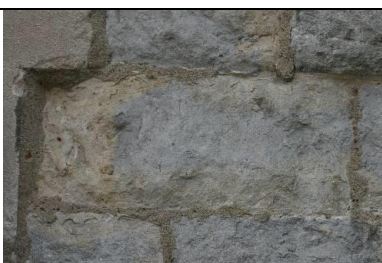
O	Market Square.- Clock Tower and Paving.	The Clock Tower completed in 1877 was designed, in the Gothic style, by the local architect D Brandon. Noggin of 'local' Middle Jurassic White Limestone (showing blue heart features) typical of North Buckinghamshire. Corners –more massive Jurassic limestones (Oxon). Plinth – Yorkstone, sandstone flags.

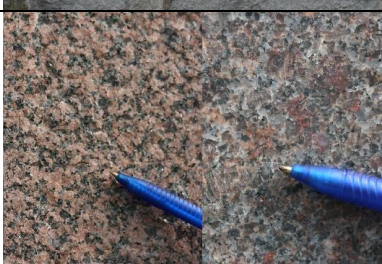
O / P	Market Square- Halifax Building Society.	Nice contrast of polished and rough faces.  Dark coloured: Finnish Red Balmoral granite, from Vehmaa, Finland.  Light coloured: Peterhead Granite, Aberdeenshire, Scotland.

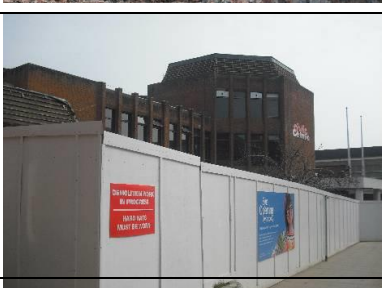
P	Civic Centre Demolition	The Maxwell Swimming Pool was excavated from Kimmeridge Clay Formation; Hartwell Silt to Swindon Clay Members

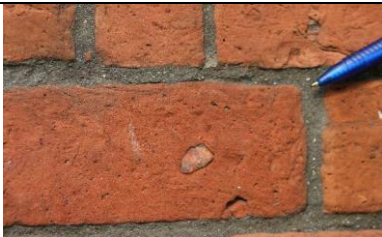
P	Market Square, Corn Exchange	Local red bricks, slightly silty with occasional clasts. Probably made from Hartwell Silts (Lockes Pit, Hartwell or Webster & Cannons Pit, Cambridge Street. Designed by D Bandom in 1865, the Corn Exchange never realised the profits its builders intended due to steep decline in the value of grain.

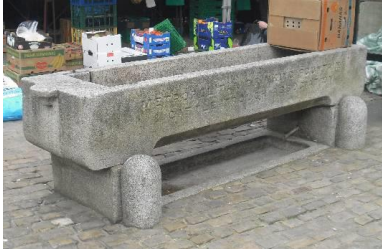
Q	Market Square, south end, Water trough,	Light greenish grey granite. Similar water troughs can be found in London, these were made from Cornish granites when railway access opened up the Bodmin Moor Quarries in Cornwall.

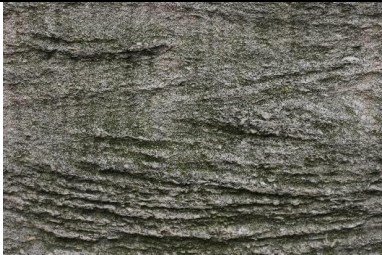
R	Market Square, south end, Lion Plinth	The recumbent lions in front of the Courts were given by Baron Ferdinand de Rothschild of Waddesdon Manor in 1888.  Coarse cross-bedded Jurassic Limestone. Weathering brings out these features well.

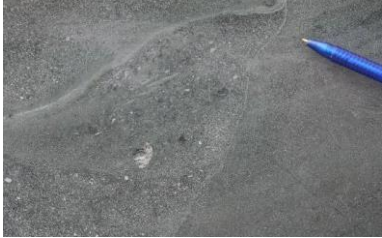
S	Market Square, Friars Square Entrance.	Tuff, (Probably Lake district e.g Honister Slate).  Volcanic in origin, fine dust settles in water sinking to the bottom as a series of layers which become compressed and deformed.

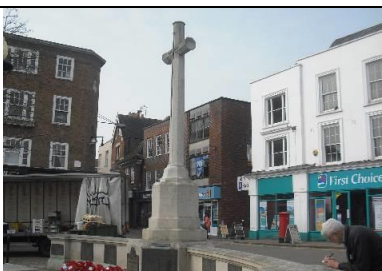
T	Market Square, War Memorial	Portland Limestone from Portland. Very distinctive white-grey limestone. Used uniformly all over the world for CWGC memorials until 1998.  Setts in Market Square are mainly sarsen but also include red Nepheline Syenite.

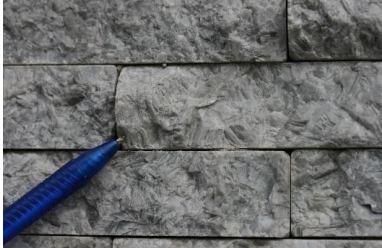
U	Panasonic, Temple Street.	Coarse Marble, calcite crystals can be easily seen. Marble is metamorphic rock, originally this would have been a limestone but has been subjected to heat and pressure and the original form has been altered. This is probably Carrara Marble from Italy.

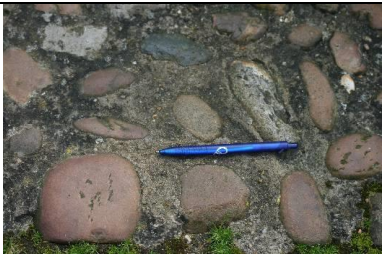
V	Kings Head Passage, off Temple Street.(Follow signs to Information Centre)	A large variety of different stone types can be found in the courtyard. This include Sarsen setts, Coach-mounting steps made from Yorkstone. Also puddingstone (variety of Tertiary sarsen), volcanic agglomerate and Bunter pebbles set into ground.

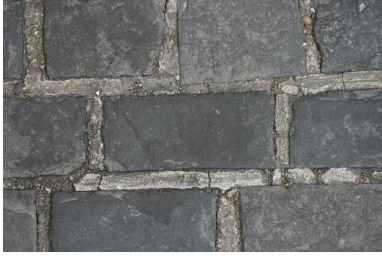
W	George Street, Opposite Queens Head (south side).	Black slate / mudstone? Setts – similar to top of High Street at entrance to pedestrian area.  Kerbs of massive sandstone, probably from northern England. Also note the man-made composite setts.

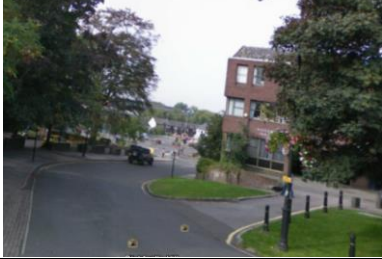
X	Rickford's Hill	Walk to break in slope to see topography caused by Portland Limestone capping Aylesbury Hill, looking down to Friarage Road.  (Refer to the cross section on page 1 ).

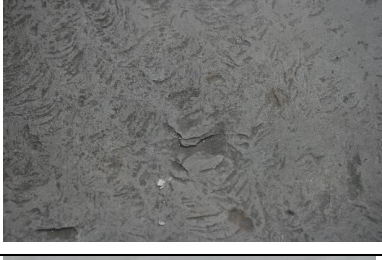
Y	Church Street, pavement near Museum.	Yorkstone with ripples. (below Thomas Hickman's house). Yorkstone is a sandstone formed during the Carboniferous. The sand layers are separated by thin spreads of the silvery mica flakes. York Stone cuts down layer by layer so that the non-slip sand surface is exposed and maintained with wear.
